Re: Shelman Trail Sub-Grade Testing

## SHELMAN TRAIL SUB-GRADE TESTING

**PURPOSE:** The purpose of the sub-grade testing performed on December 15, 2009 was to evaluate the condition of a sub-grade placed in March of 2009 and treated with Roadbond en1.

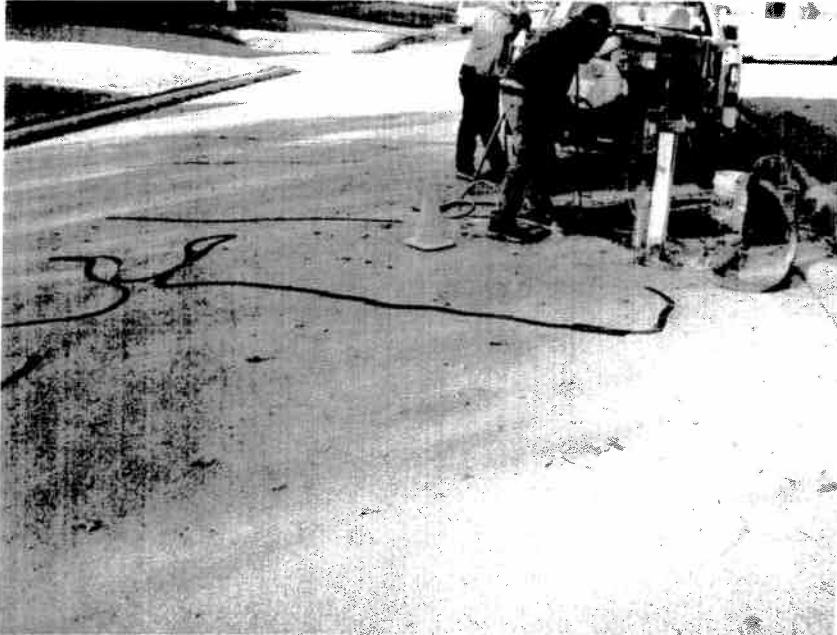
Picture #2-Sample taken from untreated area-recently crack sealed with asphalt.

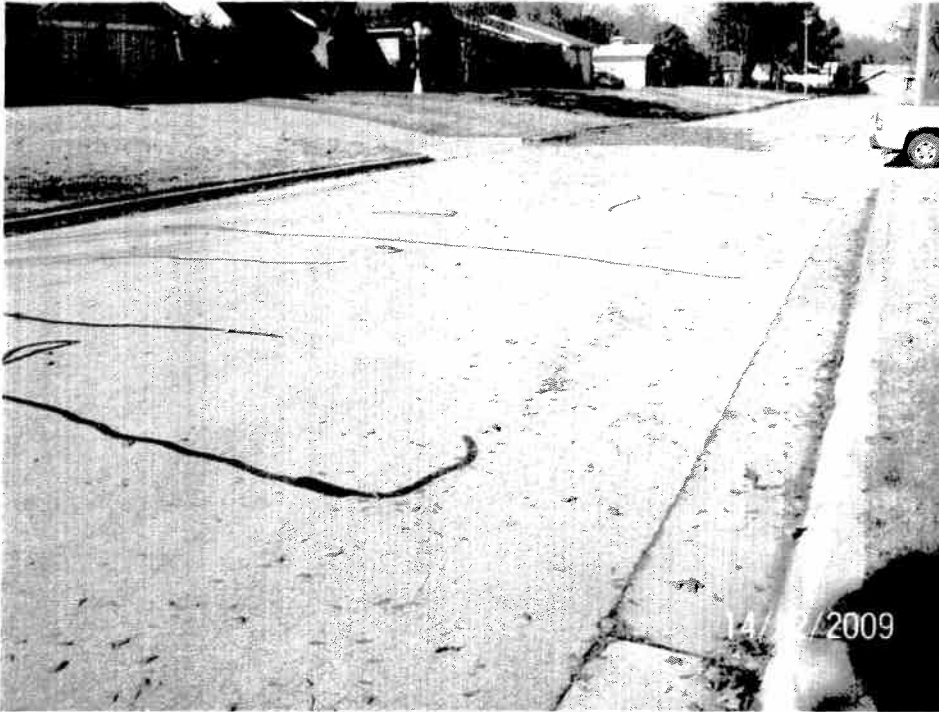
The asphalt at location K-4 (1905 Shelman Trail), outside the test area, was 2.5 inches thick. The blow count was 26 (about 9500 psf). The blow count on the second layer was 24 (about 9000 psf). The presence of a large rock prevented getting a blow count on the third layer. See Picture #3 for test location and to note recent crack sealing. The moisture level in the base course was 8.4%.

Picture #3-Untreated area-Note extensive shrinkage cracking. No trees in this area.

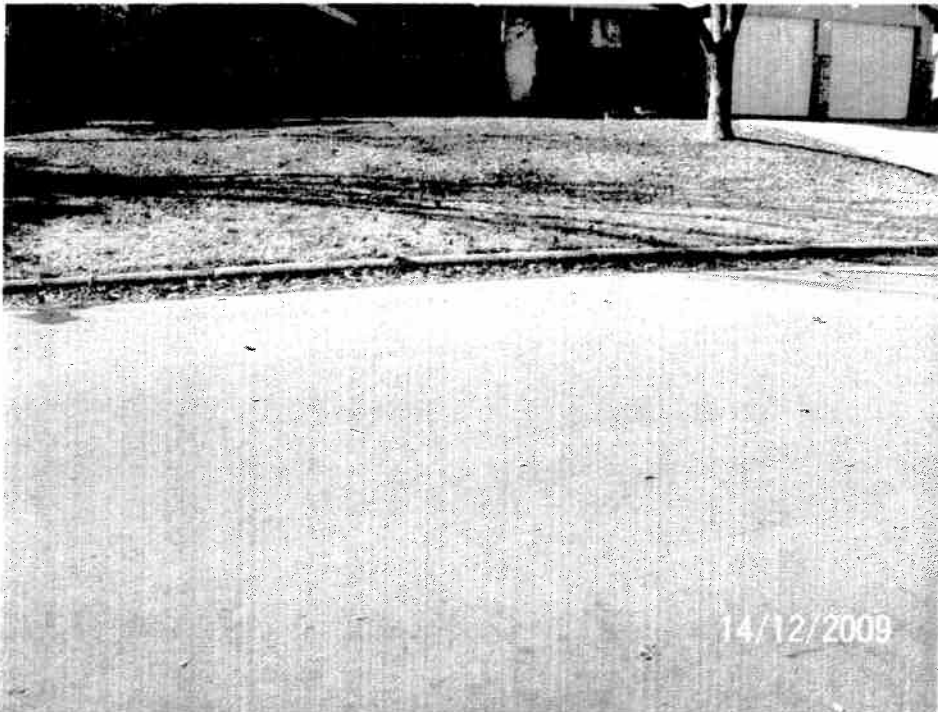
The current condition of the test section is excellent. There are a few very fine cracks in the area of the trees which are too fine to rout and seal. These very fine cracks were apparently caused by clay shrinkage due to water demand by the tree roots. Outside the area of the trees, the condition of the test section is near perfect (See picture #1 & #4). There is no rutting or stress cracking anywhere in the test section.

The asphalt at location K-3 (1908 Shelman Trail), outside the wooded area, was 2.5 inches thick. The blow count on the base course was forty-four (44). That is equivalent to approximately 13,000 psf. The blow count on the second layer was 26 blows (9500 psf), but dropped sharply to 4 blows in the third layer which was untreated and contained no aggregate. The four blow reading in the untreated soil is equivalent to about 3000 psf, the lowest value available for input into the WINPAS street design program for sub-grade. This compares to other tested locations in similar soils. The moisture levels in the base course material averaged 10%. The moisture level in the 12" to 18" level was 17.9%.

Picture #4-K-3 location-Blow count was 44. No trees in this area.
