SUBGRADE TESTING REPORT-25April2016

CITY OF FORT WORTH STREETS-18 YEARS OLD OR OLDER

ROADBOND EN1 w 3% CEMENT VS 6% CEMENT

PREPARED FOR STEVE MERRITT, ROADBOND SERVICE COMPANY

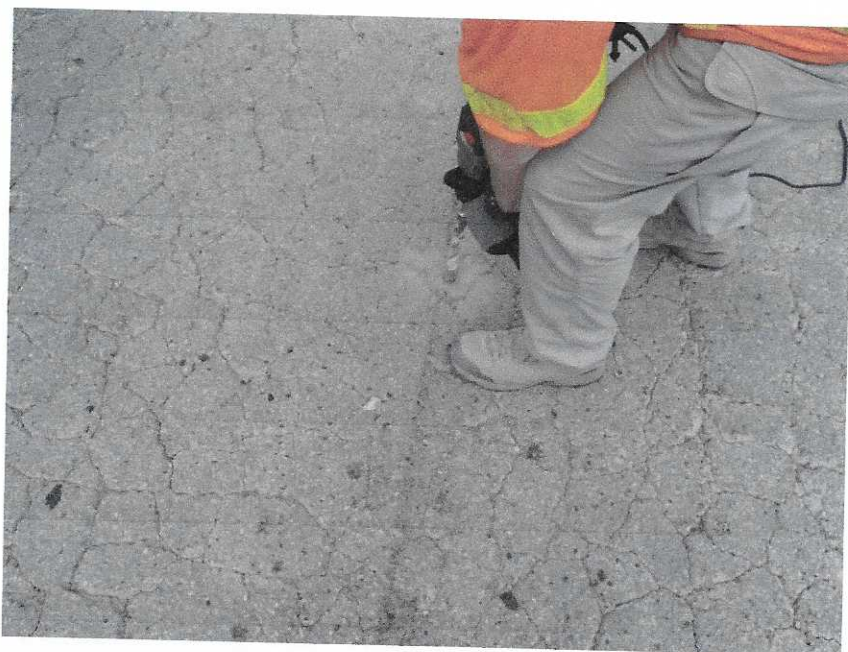
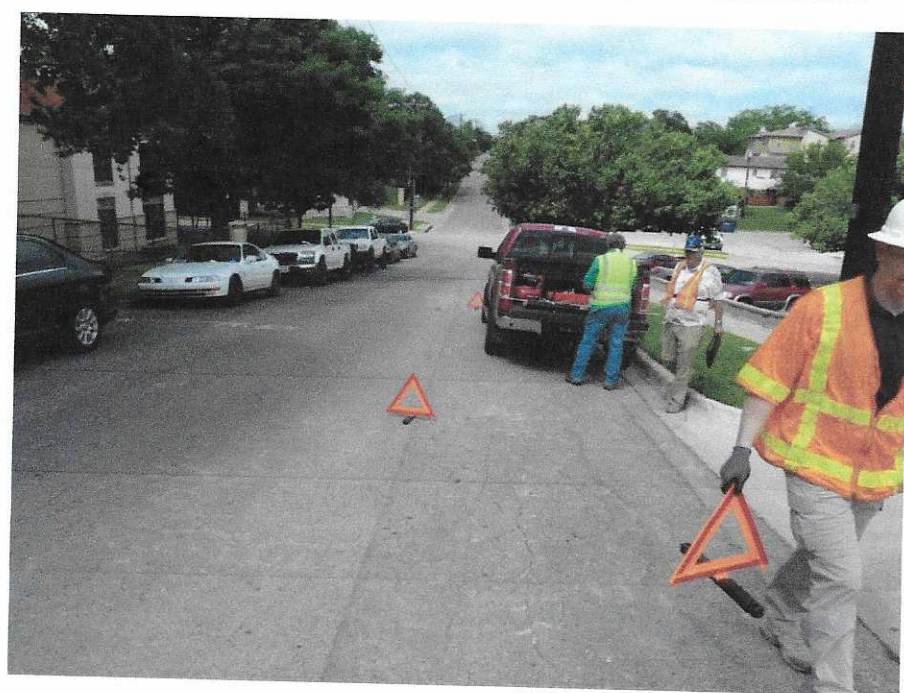
The pavement surface behind Pascal High School was in good condition and had minor crack sealing. The one test hole with Roadbond EN1 and 3% cement had a value of 767. The other test hole readings were discarded for reasons outlined above. The average value of the two test holes on the 6% cement section between Forest Park and McCart was 29. The pavement surface had failed completely and was marked by severe alligator cracking. Alligator cracking is

symptomatic of base failure. Pot holes were already forming. This section of paving requires immediate attention. See photos attached.

W. Lowden St. between Forest Park & McCart (note alligator cracking)

Potholes are beginning to form in the Center of the street

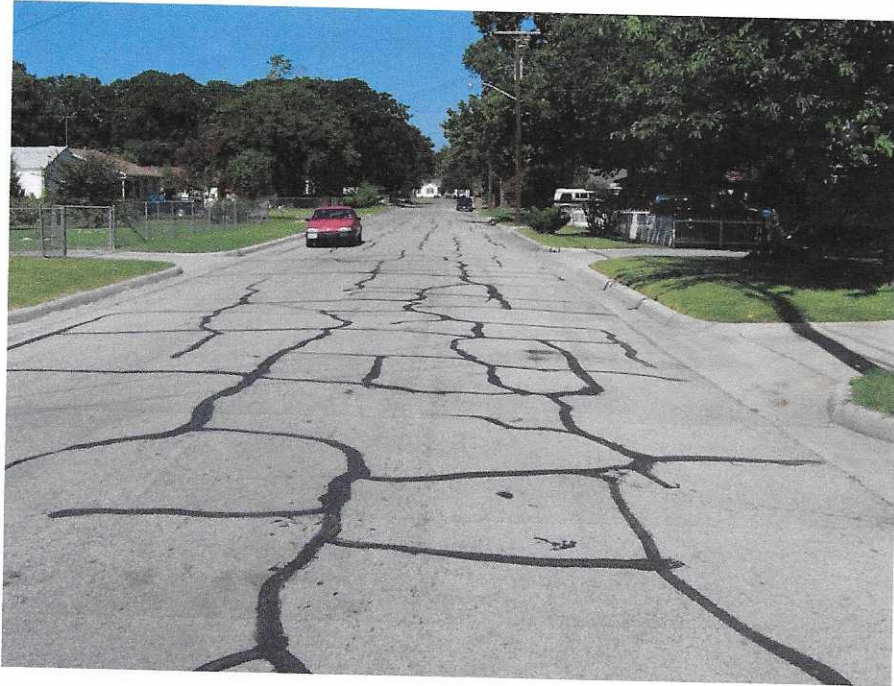
Picture from 2004

The pavement surface in the 3800 block was in generally good condition in the section where Roadbond EN1 was used with 3% cement. The average value of the 3 test holes was 204 (138,245,228). The average value of the two test holes in the 3700 block was 211(315,107). The pavement surface showed extensive block cracking which suggested that the cement percentage applied by City of Fort Worth crews was substantially above 6%. The two readings vary widely. The cracks had been properly sealed and, though unsightly, there was no evidence of impending pavement failure. See photo attached from 2004.

3700 Blk of Earl St. Note extensive block cracking in 6%? Cement section.

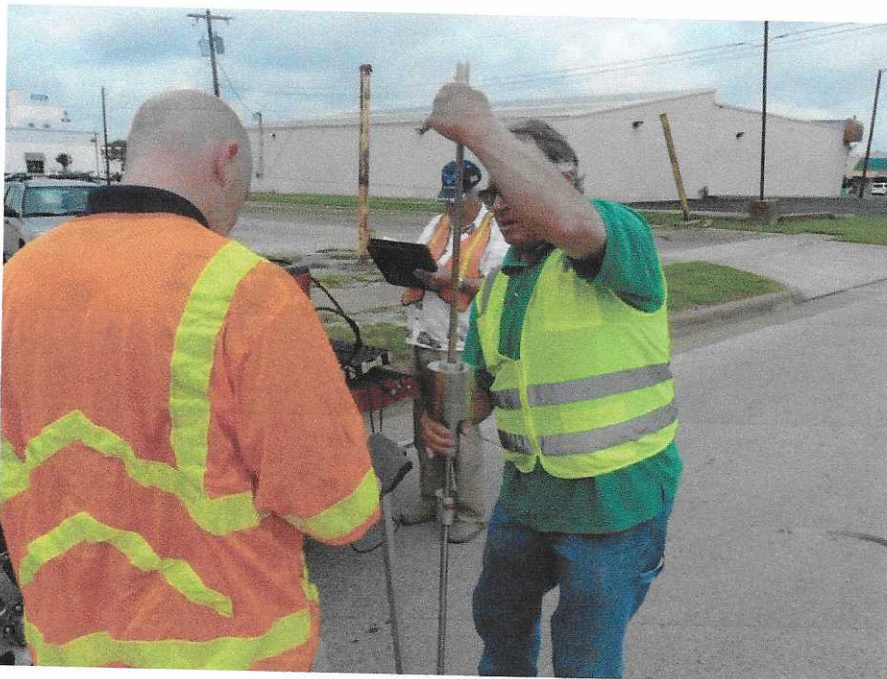
Preparing to take readings at location on Floyd Road

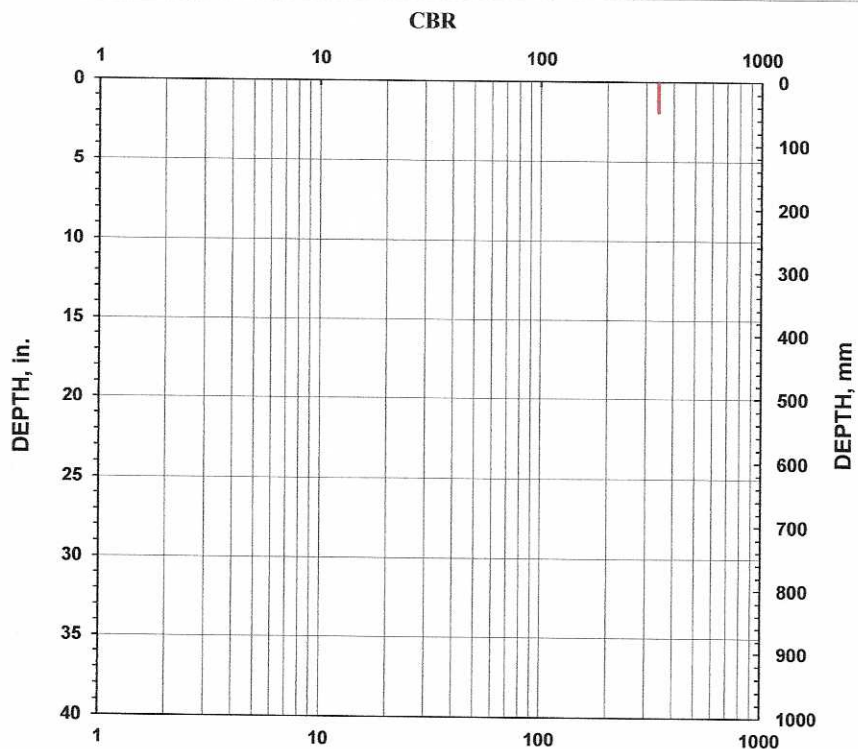
Average CBR 340.

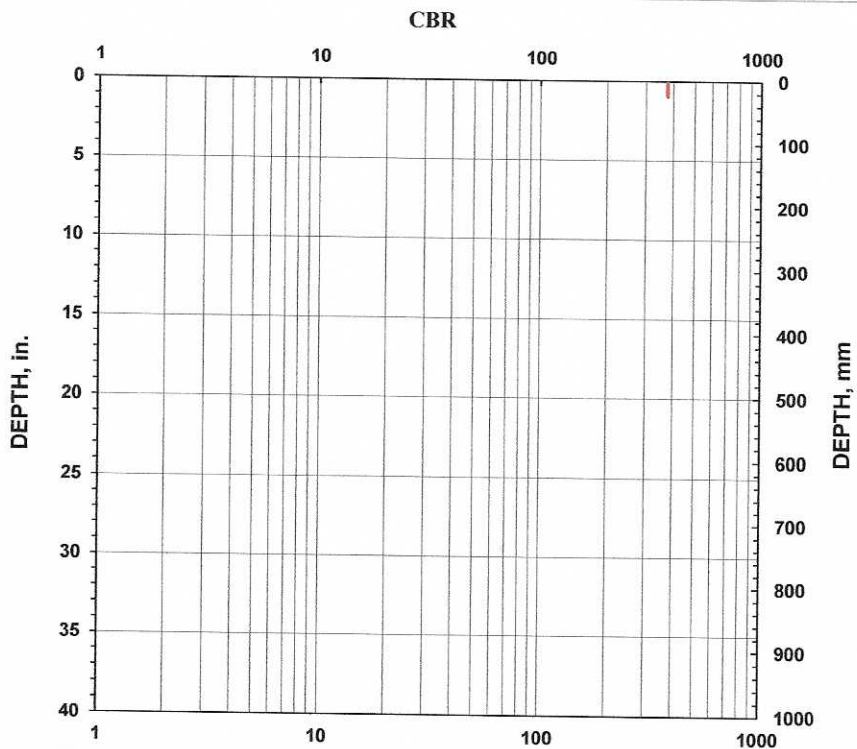
Average CBR 375.

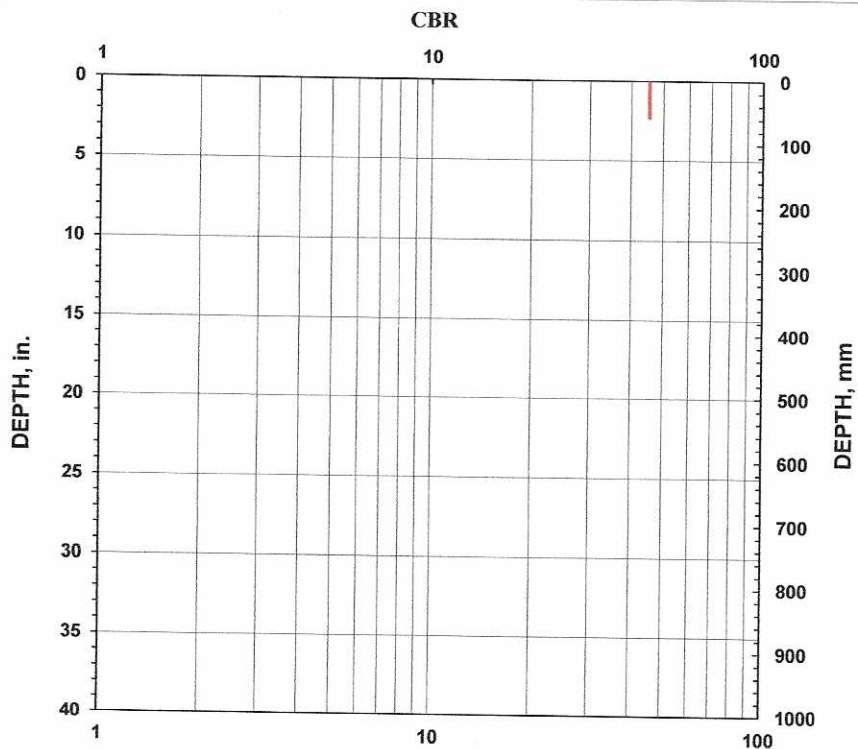
Average CBR 45

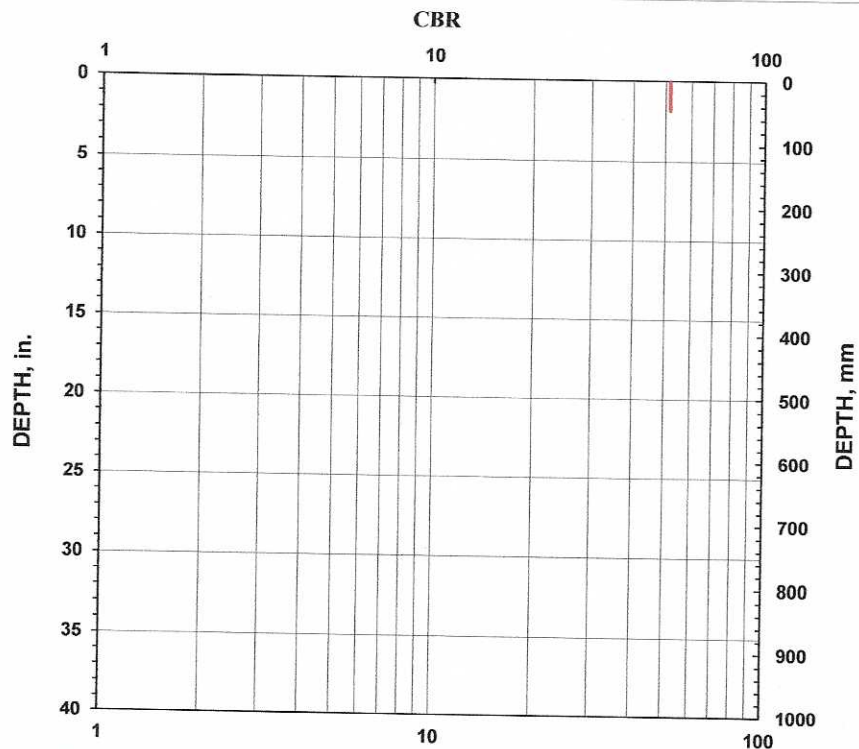
Project: Floyd Dr.-Hole #4 w 6% Cement

Average CBR 52

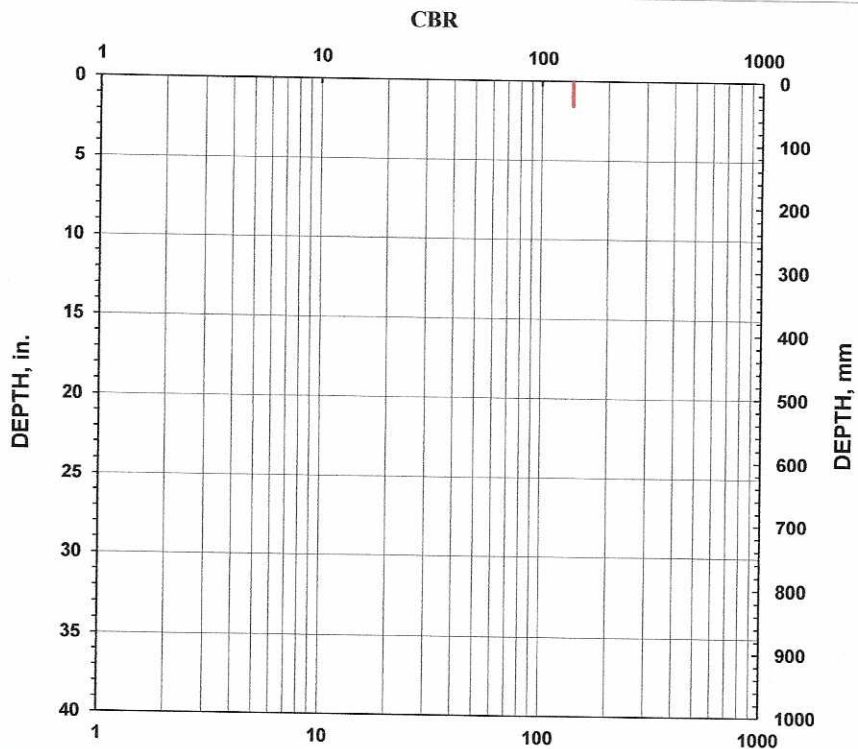
Average CBR 138

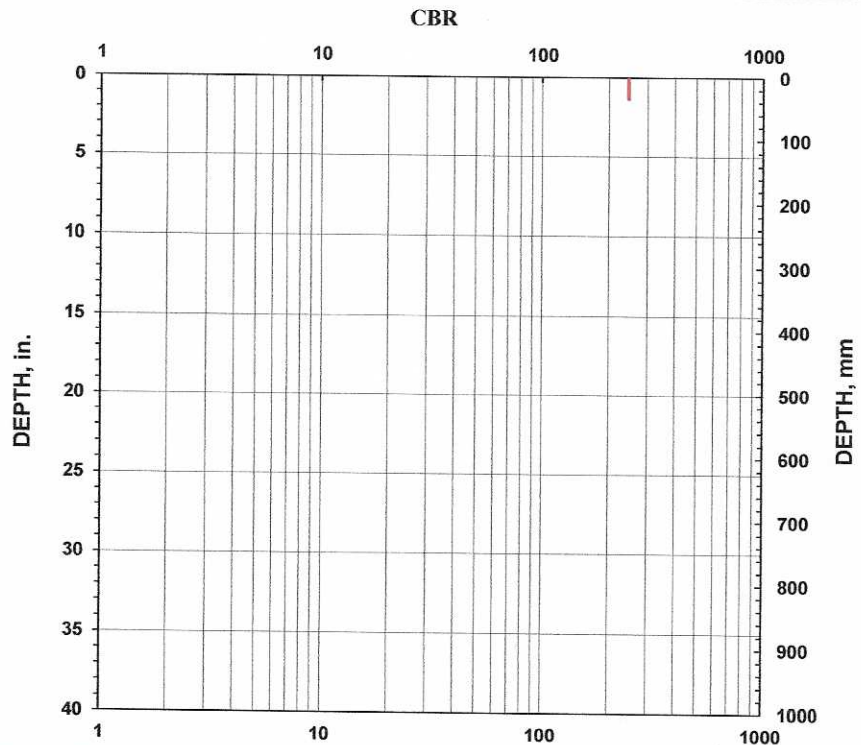
Project: EARL ST.-HOLE #2-RB & 3% CEMENT

Average CBR 245

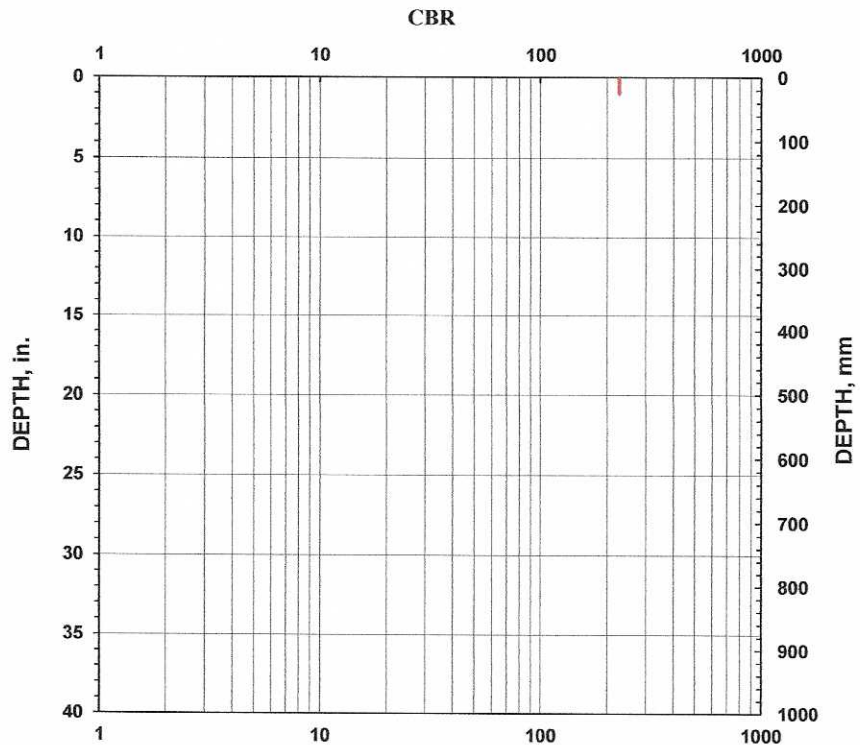
Average CBR 228

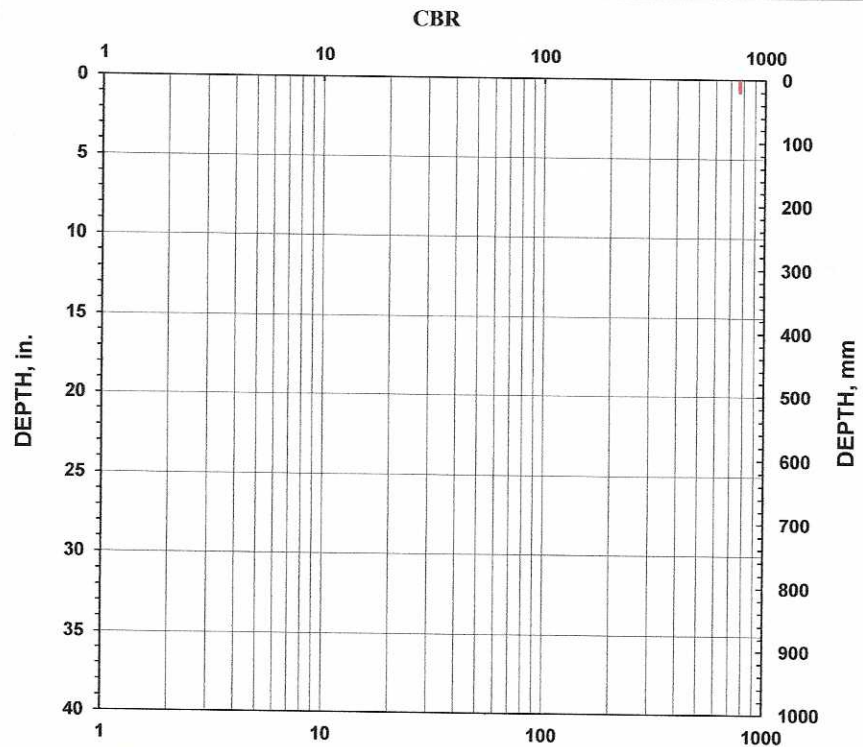
Average CBR 767 7

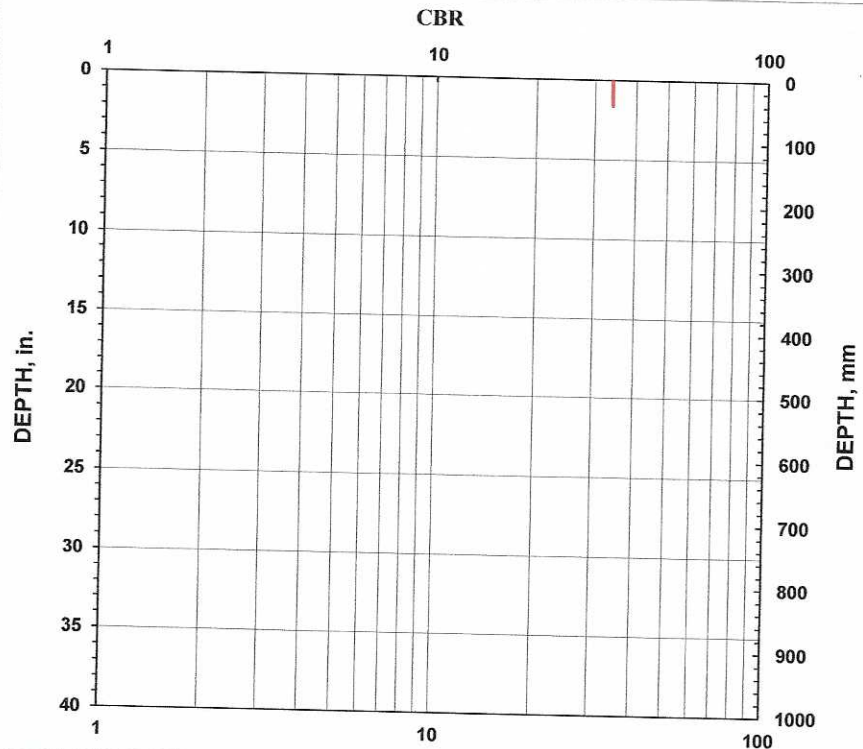
Average CBR 34

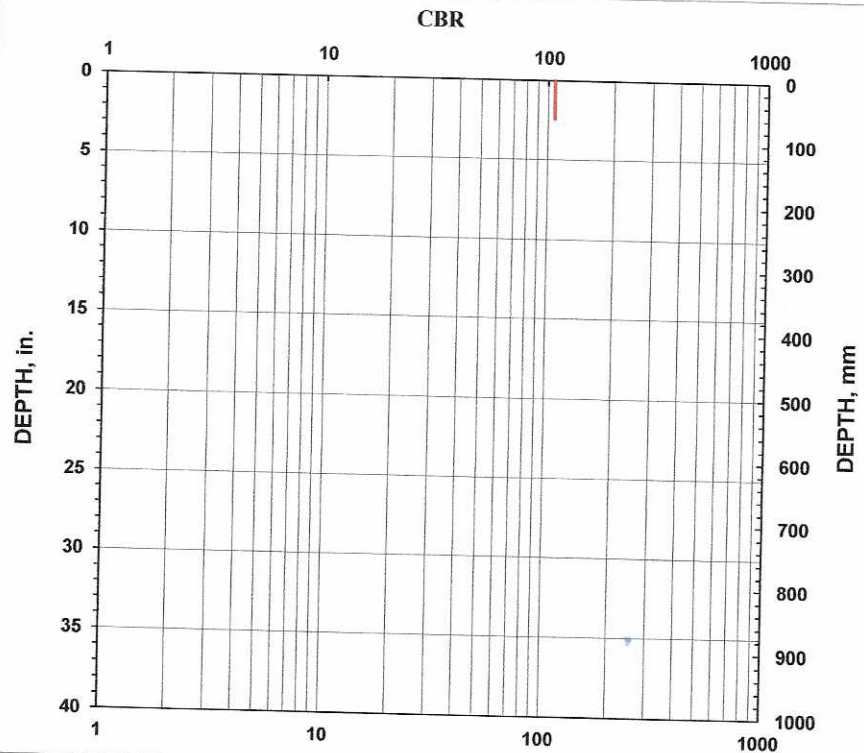
Average CBR 107
