STUDY NO. F-5; Non-Standard Stabilization

**Douglas E Scholen
USDA Forest Service
Southern Regional Office
Engineering Directorate
1720 Peachtree Road
Atlanta, Georgia 30367
(404)347-2349**

This Study is part of the Coordinated Federal Lands Highways Technology Implementation Program (CTIP). It will serve the immediate needs of those who design and construct Federal Lands Highways, plus it will be helpful to many other agencies, states, counties and private parties .

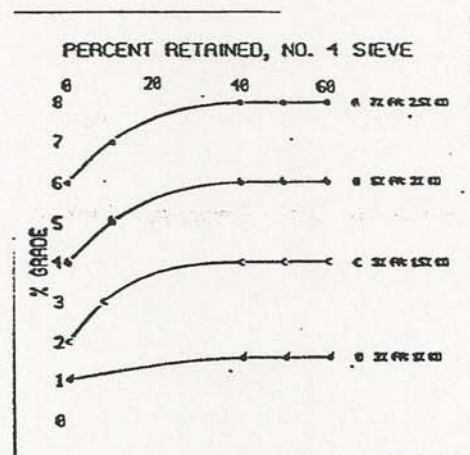
for these projects ranges from a few months to 7 years. Based upon observations to date, the percentage of additive required for satisfactory performance of a coarse aggregate is estimated to vary with the road grade, from 1 percent for grades less than 2 percent, to 3.5 percent kiln dust or 7 percent Class "C" flyash for grades over 7 percent (Figure 7). Using lower percentages than those indicated has resulted in development of surface corrugations. Occasional shallow potholing develops on flat graded sections due to washing of fines in puddles under traffic. A light blading once or twice each year provides for optimum service.

Figure 7. Estimated minimum percentages of Class "C" flyash or kiln dust required to prevent corrugations on grades.

road surface hardened noticeably after 24 hours indicating that hydration was causing cementation of adjacent sand grains. Full strength is reached well within the 4 or 5 days curing time recommended by the manufacturers (Figure 7).

These sections have provided particularly useful insights to the percentages of additives required to prevent corrugations on steeper grades (Figure 6).
